# Restoration and adaptation of a twentieth century residential multi-family two-storey house for use as headquarters of a community movement.

## The Case of Avenida Modelo

**KIPERMAN, Flavia Boghossian (\*)**

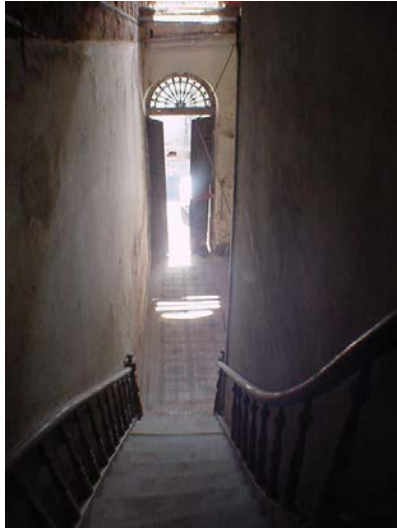
Overhead view of entrance hall

The two upper ground floor rooms are in a wretched state, with uneven floors and a dividing wall that has almost collapsed. The paved-stone floor in the corridor has missing parts and the wooden ceiling no longer exists, there are only a few panels. Much of the telephone and light wiring that lines the ceiling is messy and poses a threat to the building.

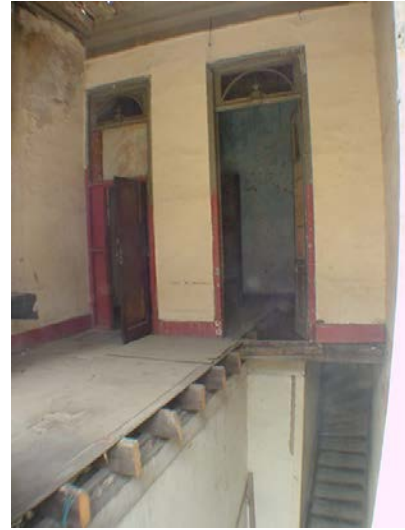
View of the main room

The wooden floor in the house is in ruins with a large gap in the front room. The frames of this room are no longer there and the internal frames seem to have been replaced. The wooden framework of the ceiling has missing boards and inadequate paintwork. The artistic paintwork in the corridor is covered with a coat of paint and needs urgent restoration, as it is completely unprotected.

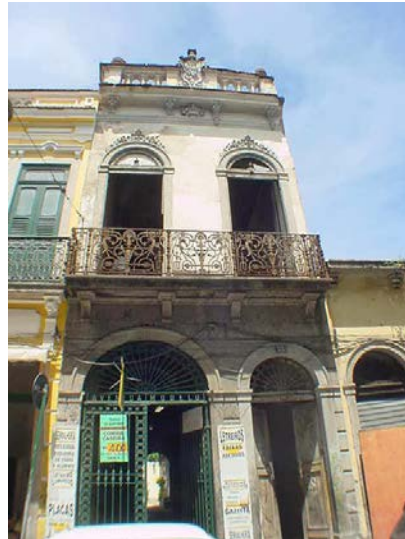
Front façade

The first floor façade is full of wires, plates and unlawful signs. The upper unit favors the appearance of fungi and lichen in the stone skirting boards.

The iron gate has missing pieces and the wooden frame is loose through lack of treatment with missing hinges and rust.

Apart from a little black crust on the stone balcony, it is well preserved and the metal parapet is complete although there is some rust. The upper banister is missing that could well be wooden.

The two doorframes were recently stolen, according to the local residents, and the remaining parts are deteriorated by time and lack of protective treatment.

The adornment of the façade is mostly complete and the missing parts could easily be fitted with prosthesis made from moulds of existing pieces.

The entire façades will be restored and the adornment will be checked and completed using silicone moulds and plaster that is compatible with the original. The colors for paintwork of the façades will be ochre; a decision made together with the auditors and under orientation of the Restoration Architect after confirmation from the artistic prospecting carried out in the location.

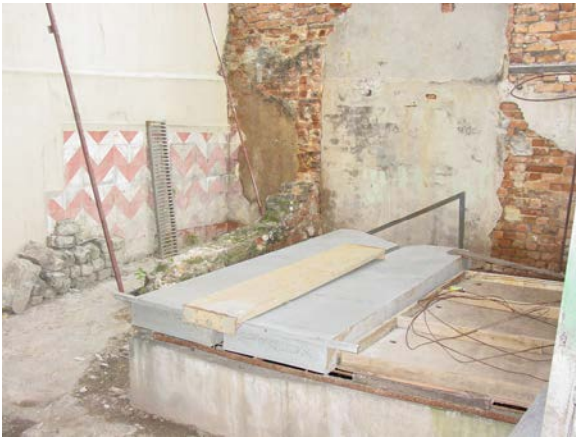
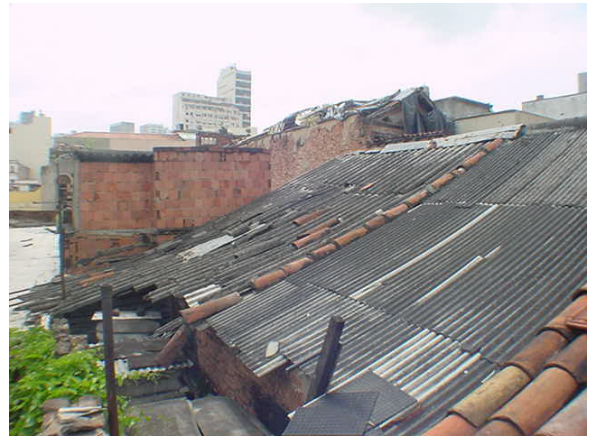
Cistern and the remains of the tiles in the old bathroom, Coverage of Avenida Modelo, located in the open patio in front of the houses.

The patio at the front of the houses is totally taken up by back yards. They are delimited by brick masonry, some with coverage, and function as small businesses. From the collective bathroom only a small hydraulic press brick wall could be recovered, similar to that of the bathroom in the house. There is a concrete cistern in front of the collective bathroom.

A smaller house or construction will be built in the area occupied by the collective bathroom for barbeques on celebration days. This building will have a removable wooden deck to hide the cistern and to place tables and chairs, characterizing a living area. There could be a sunshade type roof in case coverage is needed.
