Social Housing in Preserved Buildings

The Case of the Valongo Architectural Complex – Rio de Janeiro.

3. Directive Plan

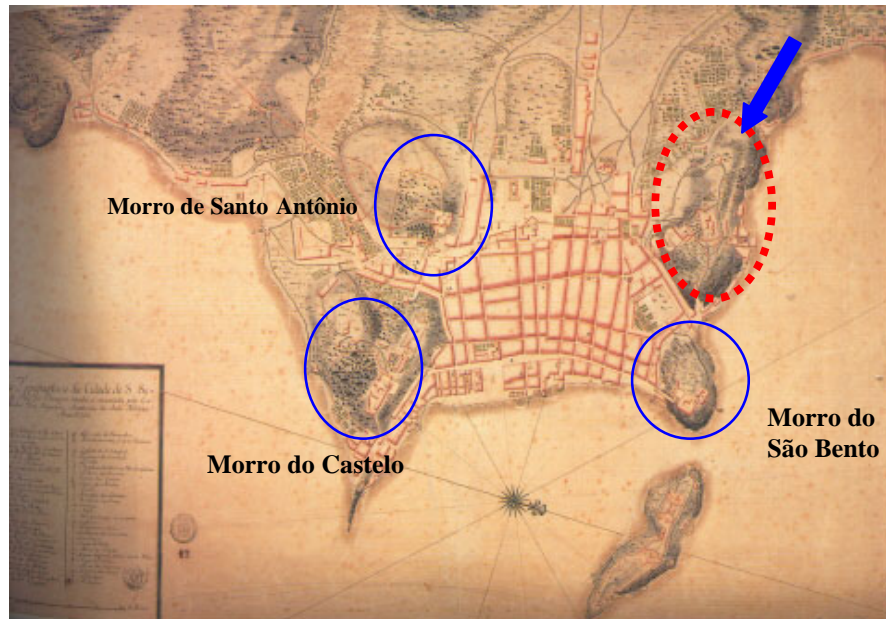
“Topographic Map of the City of S. Sebastião do rio de Janeiro...” Original manuscript from André Vaz Figueira, of the National Library, Rio de Janeiro, 1750. (REIS, 2000:169)

..... Morro (Hill) da Conceição ————— Others Hills
➔ Location of the Valongo Architectural Complex.

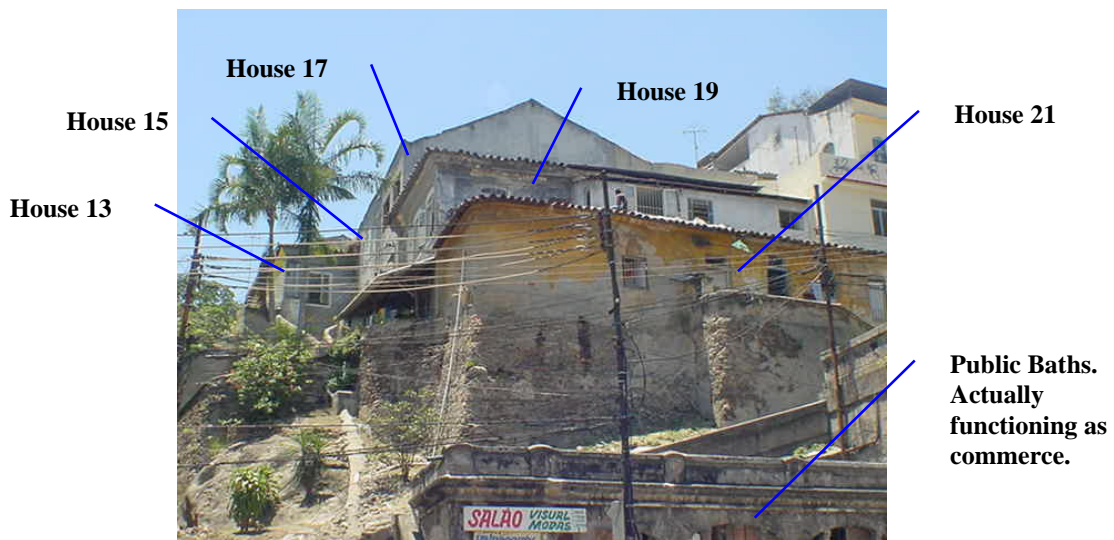
The Valongo Architectural Complex today. Photo by author in 2002.

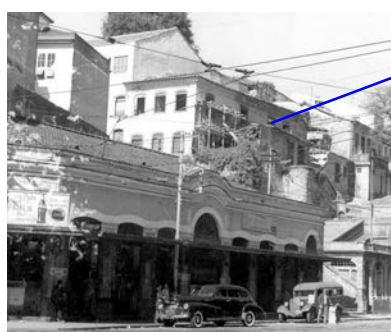
house 19

Unknown author, undated. IPHAN file

The three houses mentioned above would be today’s houses 19, 17 and 15; 19 having two dwellings, second floor and two-storey, forming 4 dwellings in 3 houses. Would this number 19 be one of the first examples of multi-family housing in Rio de Janeiro?

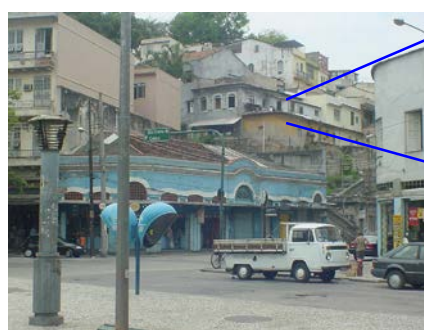
Photo of the present state of conservation.

Today there are 5 residential units in a precarious state of conservation. There are infiltrations of rain water, visible sewage, rooms without ventilation or light recently built, unstable slabs and exposed ironwork.
