# Restoration and adaptation of a twentieth century residential multi-family two-storey house for use as headquarters of a community movement.

## The Case of Avenida Modelo

**KIPERMAN, Flavia Boghossian (\*)**

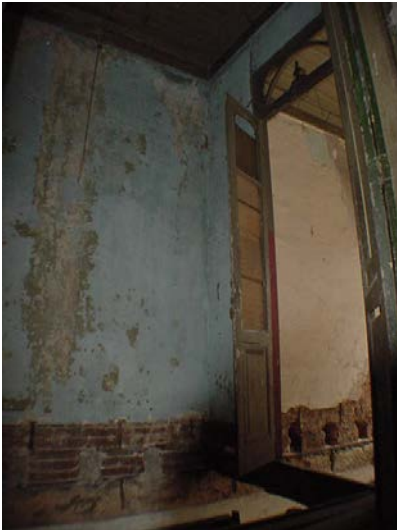
View of the room in the upper storey

The wooden floor in the house is in ruins with a large gap in the front room. The frames of this room are no longer there and the internal frames seem to have been replaced. The wooden framework of the ceiling has missing boards and inadequate paintwork. The artistic paintwork in the corridor is covered with a coat of paint and needs urgent restoration, as it is completely unprotected.

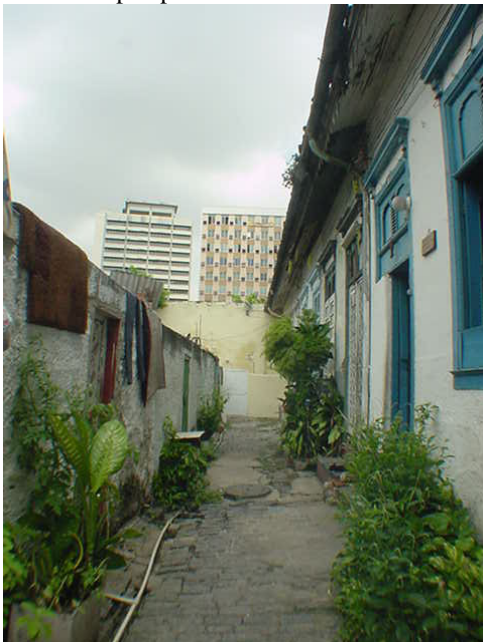
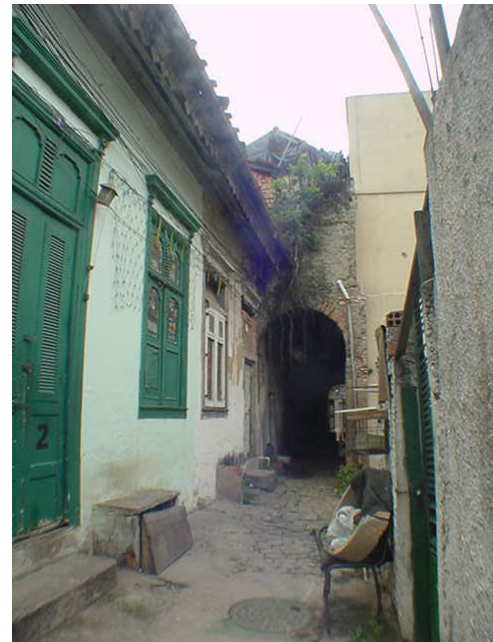
Photos of Avenida Modelo

The roof is in a bad state of conservation and is mostly covered by undulated fiber cement tiles. Also, inadequate tiles have replaced the skylights. The lambrequin detail is complete but the protection and gutter have many weak points with dents, splits and dirt.

Many of the internal openings were closed with new bricks. Moreover, the uncovered area at the rear was closed to fit the bathroom and a small kitchen. Most of the coverage in this area is concrete slabs. The cement floor and the wooden framework on the ceiling is in a bad state of conservation or has been completely replaced by inadequate building material.
